PRODUCT BULLETIN

HEAT IN THE HUB

Bulletin No: KPM-001-0518 1

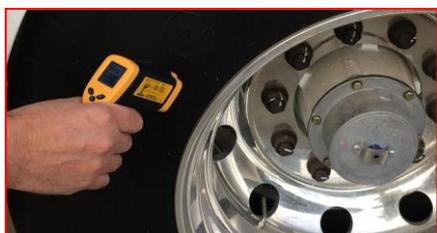
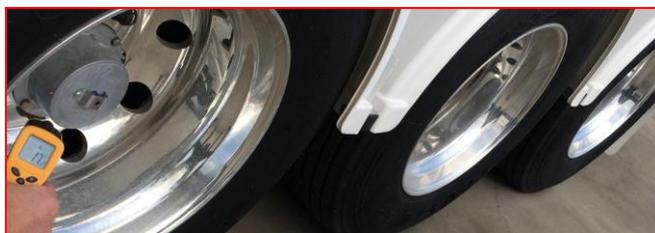
There are a number of factors contribute to the heat ending up in the hub (see diagram above), and therefore a “higher” level of heat will **not** automatically lead to the cause of the excessive heat (*..not enough grease!!*).

Check the brakes, remove the hub cap**, jack-up the wheel and do a rotation check...etc etc.

**If the grease has been running in excess of 150°C, it will start to deteriorate, blacken and smell burned. The cause of that overheating must be rectified and the grease replaced. Check the bearings for any heat damage.
